PERIPHERAL CIRCULATION FOR LOW-COST CENTRAL HEATING IN OLD HOUSES

Production Research Report No. 124

Agricultural Research Service
UNITED STATES DEPARTMENT OF AGRICULTURE

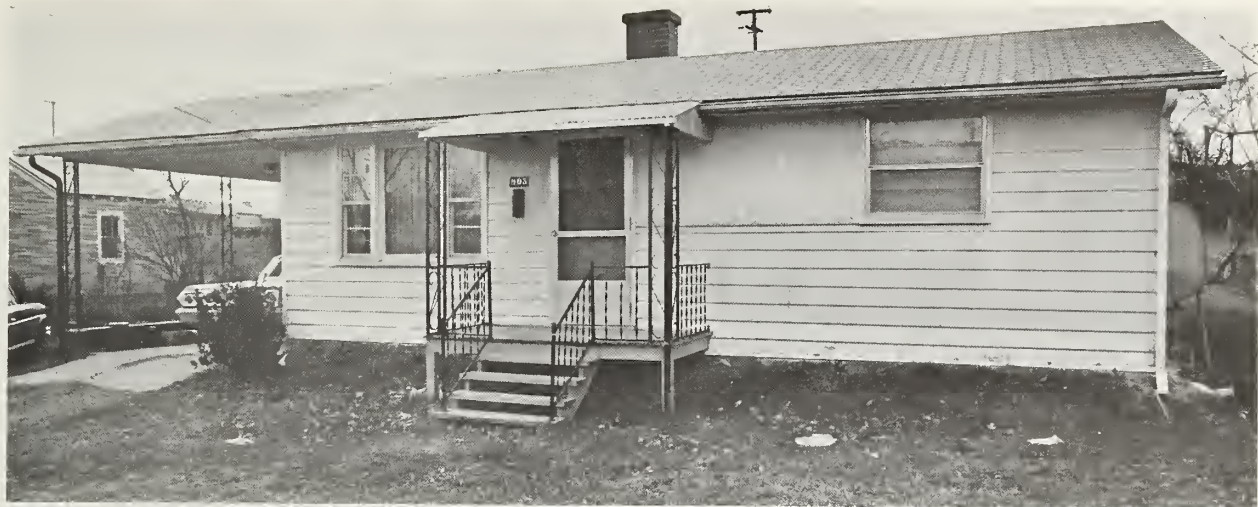
BN-37630

FIGURE 2.—Testhouse located at Blacksburg, Va. Peripheral circulation was added to the existing system to distribute the heat from the 65,000-B.t.u./hr. specifications already in use.

The house selected is wood framed, with lap siding and drywall interior surfaces (fig. 2). The L-shaped floor plan of this three-bedroom house is shown in figure 3. The total floor area is 856 square feet. The floors are hardwood over plywood on 2- by 8-inch floor joists, and the roof is constructed of standard rafters with plywood sheathing and 235-pound shingles.

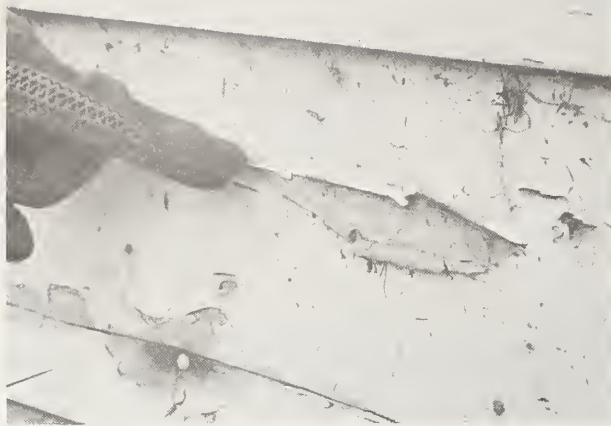
BN-37629

FIGURE 4.—Moisture migrating from crawl space had condensed under paint and caused blisters.

In general, the paint on this 4-year-old house was in good condition except for the lower siding boards that extended below the floor level. The paint on these boards had blistered and peeled considerably, as shown in figure 4. This damage indicated that moisture was migrating from the crawl space through the lap siding. Because the moisture could not pass through the paint film, it condensed under the paint and caused the paint to loosen. Gradually more and more moisture collected under the paint film, pushing it away from the board.

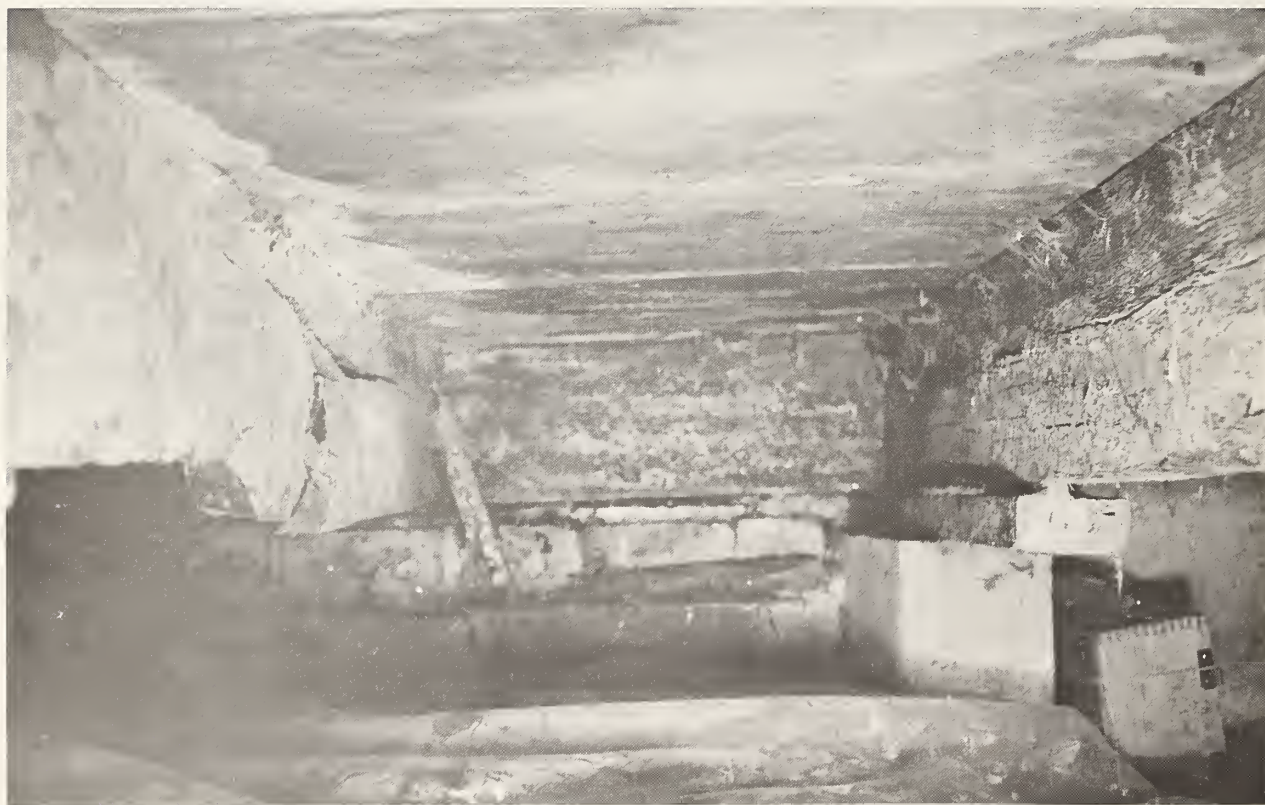
BN-37626

FIGURE 5.—Rotten floor joists caused by excessive moisture in crawl space.

Under the house the ground was muddy, and under the back bedroom frost had formed on the joists and headers adjacent to the outside wall (2 feet around perimeter). Water had condensed and was dripping from the headers under the front bedroom. Mold or fungi was evident on all floor joists under the back bedroom, especially on those timbers within 2 feet of the outside wall. Some of the timbers were rotten (fig. 5). Floor joists under the back bedroom contained as much as 49-percent moisture.

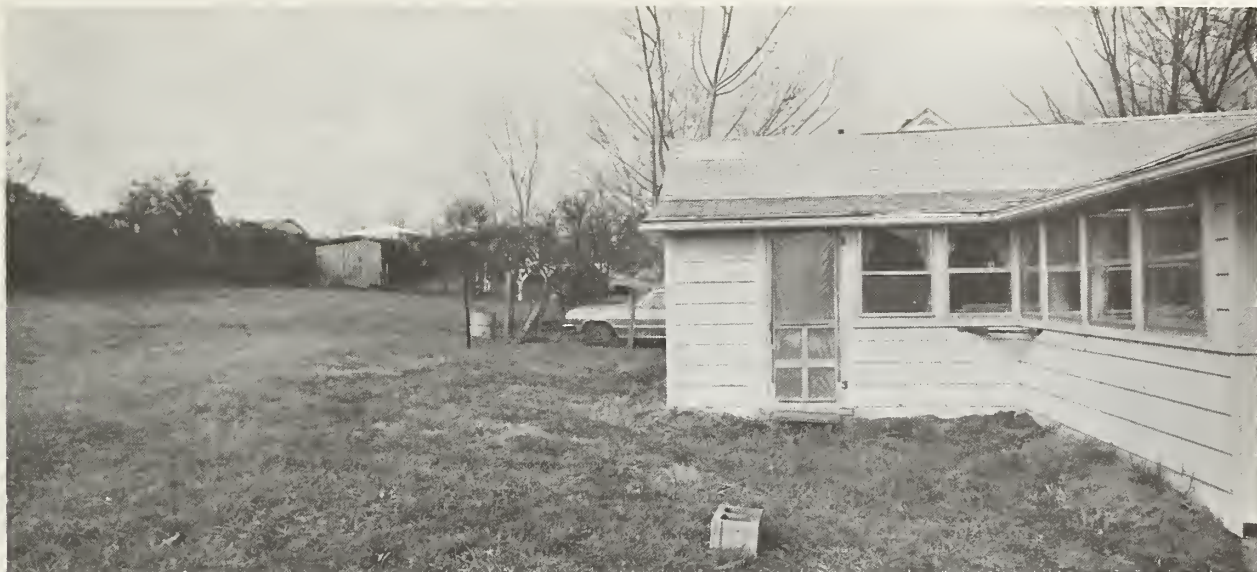
BN-37627

FIGURE 6.—The grade sloped toward the house, causing water to flow along and seep into crawl space.

The crawl space did have vents in the foundation wall, but most of them were not open. In some places the grade along the house was sloped toward the structure (fig. 6).

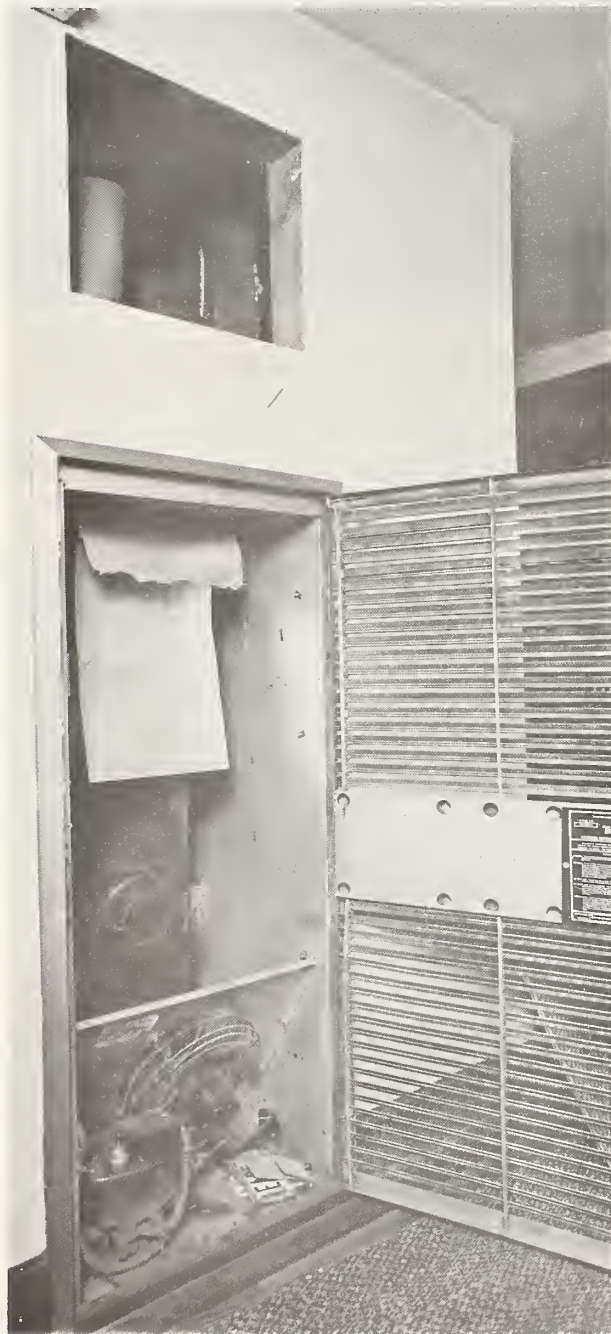
BN-37628

FIGURE 7.—Wall stove, which was the original heating system.

The house was heated with a 65,000 B.t.u./hr. oilstove that was recessed in the center wall of the living room in a metal-lined compartment (fig. 7). The burner operated from a high flame to a low flame by the signal from the wall-mounted thermostat. A small fan was mounted in the stove compartment and thermostatically controlled to prevent overheating of the stove; it created a turbulence in the compartment but was not large enough to distribute air throughout the house.

A grill at the top of the stove allowed hot air to escape from the metal-lined compartment, and a similar grill below allowed cool air to enter the compartment. There was no positive air movement in the house, and heat was distributed by the natural forces of convection.

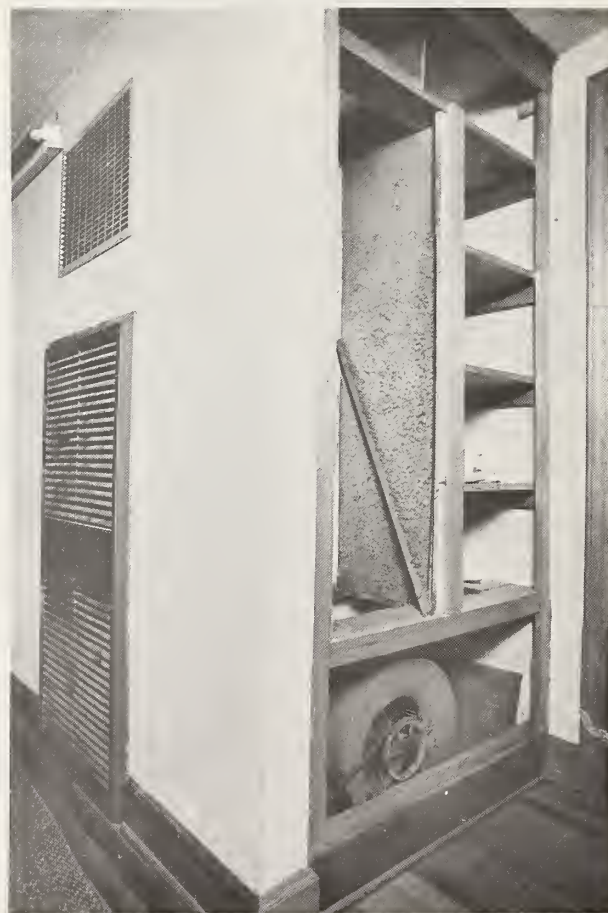
BN-37631

FIGURE 8.—Central duct and fan installation.

The next problem was to find a suitable spot for a central duct. A small built-in bookcase containing several shelves was located beside the wall stove near the center of the house (fig. 8). The shelves could be removed to allow the central duct to be installed. The blower could be mounted at the floor level in the duct, at the top of the duct, or in the crawl space. The most suitable place, and that selected in this house, was at the floor level where the duct could be enlarged to accommodate the blower. The shallow crawl space was not selected because it would be difficult to service the fan. Locating the fan at the top of the duct would cause excessive vibration and noise.

the floor at its base. Then rubber mounts were installed to support the fan and to reduce vibration. A 1,200-cubic-feet-per-minute blower was installed over the opening in the floor and provided with electric power. Except for the 144-sq.-in. air intake at the top, the front of the bookcase was enclosed to develop a chamber around the fan and to form the central duct. A 77-sq.-in. opening was made between the top of the central duct and the stove cabinet to form a short circuit duct to allow the hot air to enter directly into the distribution chamber. The crawl space wall was sealed by calking all cracks, and a plastic vapor barrier was spread over the soil. In the living area the shoe molding was removed along all outside walls, and $\frac{3}{4}$ -inch holes were drilled 4 inches on center under the shoe molding. Then the shoe molding was blocked up one-eighth of an inch and nailed in place (fig. 9).

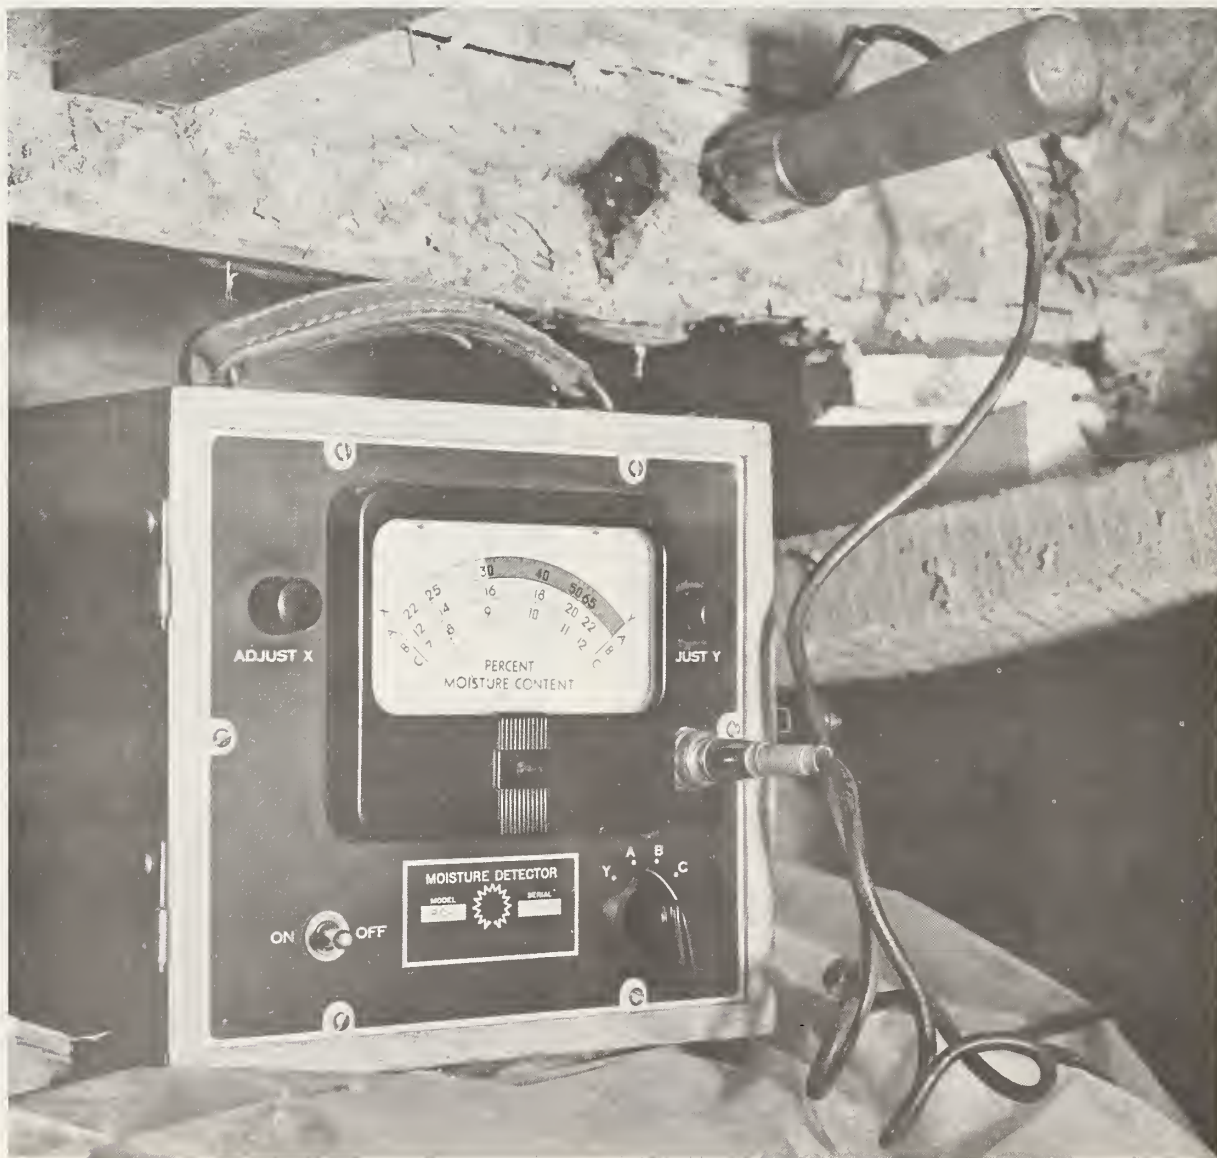
BN-37633

FIGURE 10.—Electrical resistance moisture meter used to measure moisture in wood.

4. An electrical resistance moisture meter was used to measure the moisture content of the framing timbers of the floor (fig. 10). Several points were selected under the house to measure the moisture contents at regular intervals.
